# Home Inspection Report

1234 School House Road  
Yourtown, US 12345

Prepared for: Bob Smith

Prepared by: The Neighborhood Home Inspector, LLC  
9600 Colerain Ave., Suite 110  
Cincinnati, OH 45251  
(518) 593-0642  
NYS Lic. # 16000046690

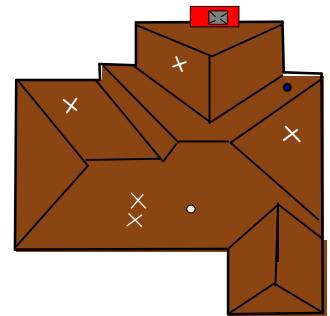
2. Roof Diagram

4. Defective Material: Fiberglass shingle, Nail popping through shingle surface in various locations causing potential water intrusion (see diagram above marked "x")

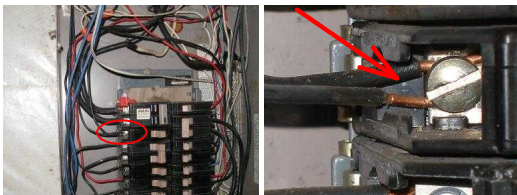
- 9. Acceptable Manufacturer: Cutler-Hammer
- 10. Maximum Capacity: 100 Amps
- 11. Acceptable Main Breaker Size: 100 Amps
- 12. Defective Breakers: Copper, Double taps are present at breakers. These circuits need to be moved to their own circuit breaker and cannot share a breaker. It is recommended that a qualified electrician inspect the new circuits and properly connect the new circuits to an individual breaker for each circuit

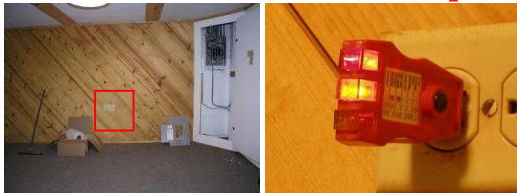
1. Not Inspected Unable to Inspect: 50%, **Basement partially finished restricting view**
2. Acceptable Ceiling: Drywall
3. Marginal Walls: Drywall, Wood Paneling, Plywood, **Damaged areas noted**
4. Acceptable Floor: Carpet
5. Acceptable Floor Drain: Surface drain
6. Acceptable Doors: Hollow wood
7. Acceptable Windows: Steel casement
8. Defective Electrical: 110 VAC, **Reversed polarity exists at several basement outlets**

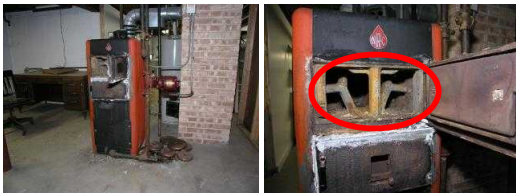
1. Marginal Heating System Operation: Recommend replacement, **Boiler system is antiquated and lacks safety features found on newer units including non-sealing combustion chamber which can cause health issues**

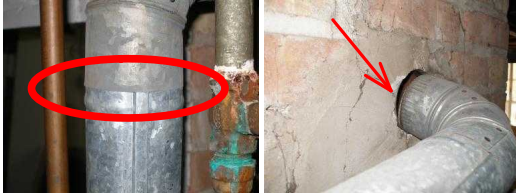
13. Defective Flue Pipe: Single wall, **Install screws at exhaust vent piping fittings, loose piping at chimney**

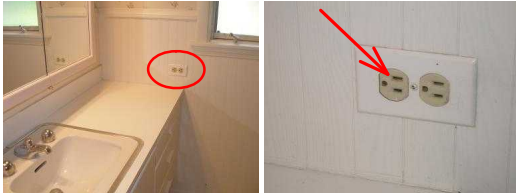
- 1. Acceptable Closet: Single small
- 2. Acceptable Ceiling: Plaster
- 3. Acceptable Walls: Plaster, Ceramic Tile
- 4. Acceptable Floor: Ceramic tile
- 5. Acceptable Doors: Hollow wood
- 6. Acceptable Windows: Wood casement
- 7. Defective Electrical: 110 VAC, **Non-GFCI circuit, Reversed polarity present**

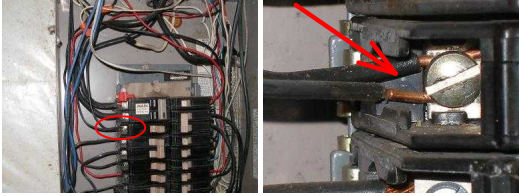
Breakers: (continued)

19. Basement Electric Panel Breakers: Copper, **Double taps are present at breakers. These circuits need to be moved to their own circuit breaker and cannot share a breaker. It is recommended that a qualified electrician inspect the new circuits and properly connect the new circuits to an individual breaker for each circuit**

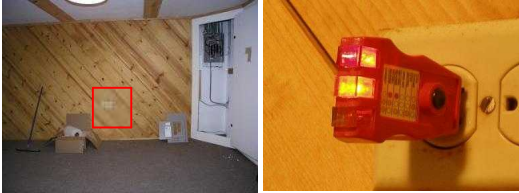
29. Main Basement Electrical: 110 VAC, **Reversed polarity exists at several basement outlets**

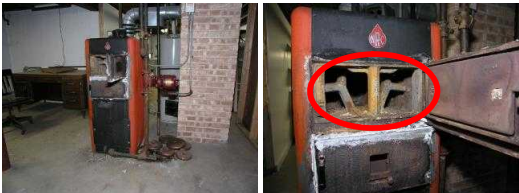
33. Basement Heating System Heating System Operation: Recommend replacement, **Boiler system is antiquated and lacks safety features found on newer units including non-sealing combustion chamber which can cause health issues**

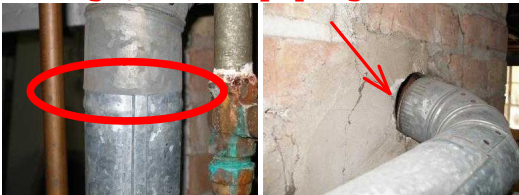
39. Basement Water Heater Flue Pipe: Single wall, Install screws at exhaust vent piping fittings, loose piping at chimney

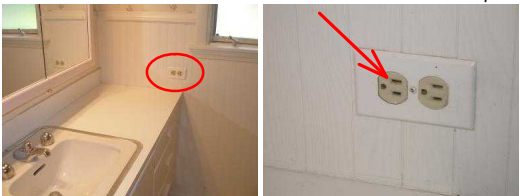
40. Hall Bathroom Electrical: 110 VAC, Non-GFCI circuit, Reversed polarity present
