Home Inspection Report

2345 Main Street
Plattsburgh, NY 12901

Prepared for: John and Mary Smith

Prepared by: The Neighborhood Home Inspector
490 Beartown Road
West Chazy, NY 12992
(518) 593-0642
NYS Certified #16000046690

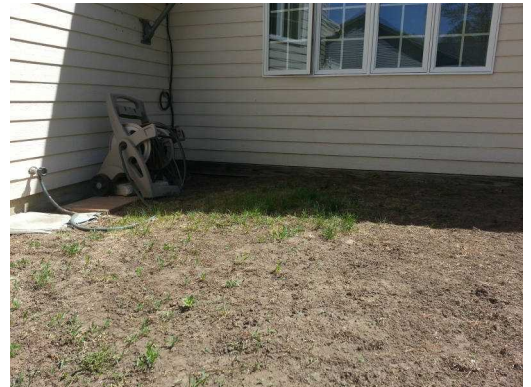
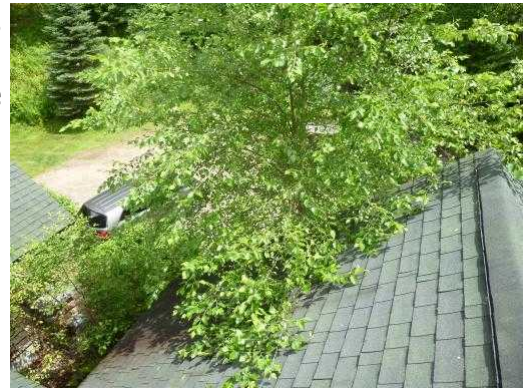
1. Satisfactory Driveway: Asphalt
2. Satisfactory Walks: Paver
3. Satisfactory Steps Concrete
4. Satisfactory Deck: Treated wood
5. Satisfactory Grading: Flat, Grade in need of improvement at rear of home near sunroom. Create a 6" drop for every 10' away from the foundation. All other areas are satisfactory
6. Defective Vegetation: Trees with typical lanscape mixture of plants and shrubs, Tree limbs over hang the roof and should be cut back to prevent mechanical and moisture damage to roof and siding areas

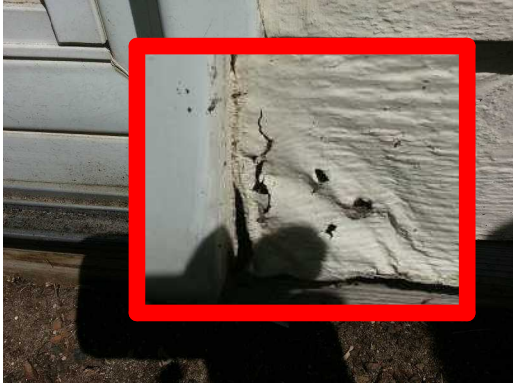
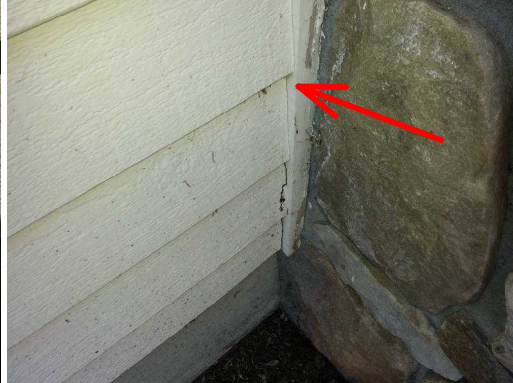
1. Defective Type: Composite Wood, Small amount of rot present at base of rear patio door and Front of home at chimney transition. Chimney transition area has water penetration into the basement at this location. Recommend further evaluation/correction by qualified contractor

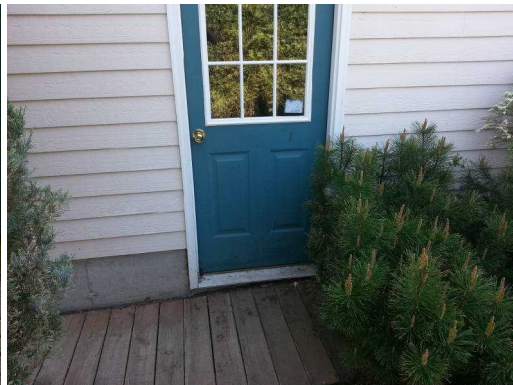
2. Defective Trim: Wood, Wood rot present at base of side door trim, Recommend correction/repair by qualified contractor

3. Trim: Wood, Wood rot present at base of side door trim, Recommend correction/repair by qualified contractor

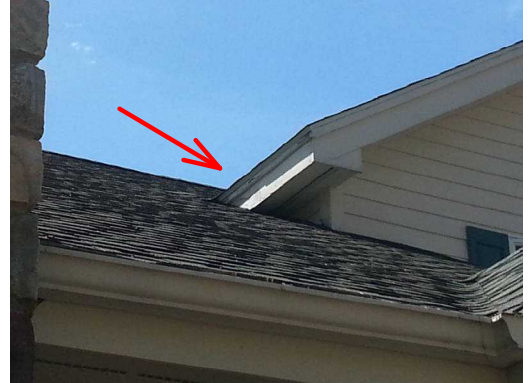
3. Satisfactory Fascia: Wood, Painting needed at upper fascia

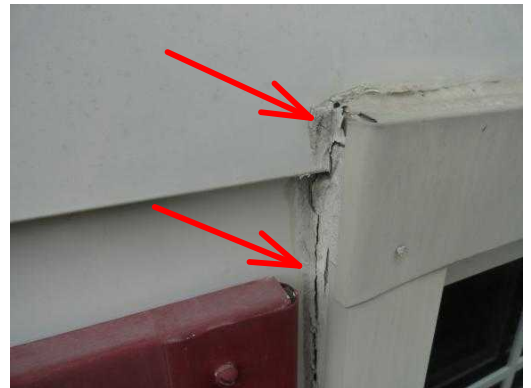
6. Defective Windows: Vinyl casement, Several windows in need of sealing. Water allowed to get behind trim when not properly sealed

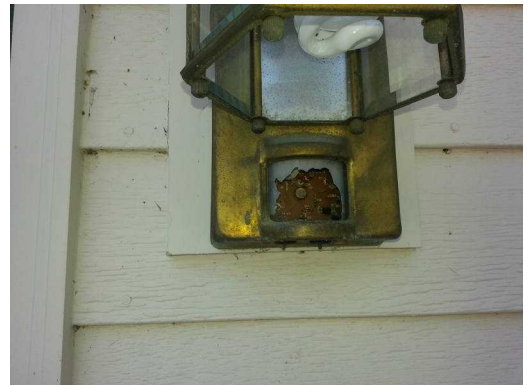
8. Marginal Exterior Lighting: Surface mount, Photo sensor glass damaged. Light is still operational

1. Exterior Lighting: Surface mount, Photo sensor glass damaged. Light is still operational

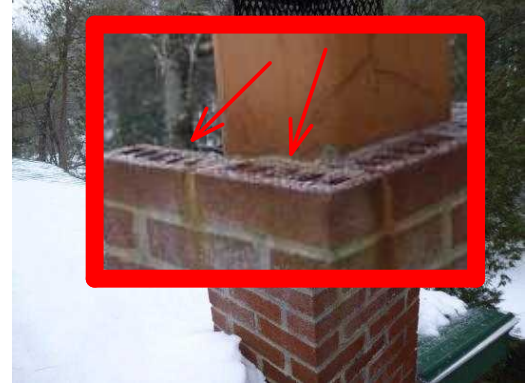
12. Defective Chimney: Brick, Chimney crown not properly installed. Crowns should be designed to deflect water and not collect it. Bricks missing and deteriorating. Consult with qualified mason for correction

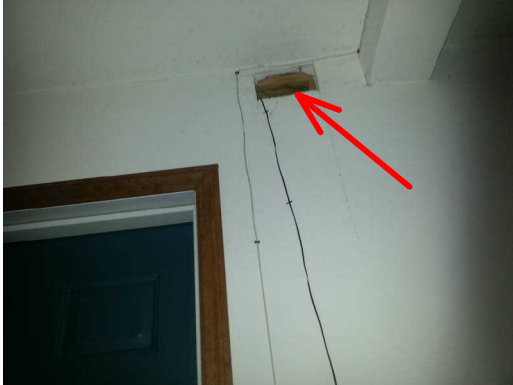
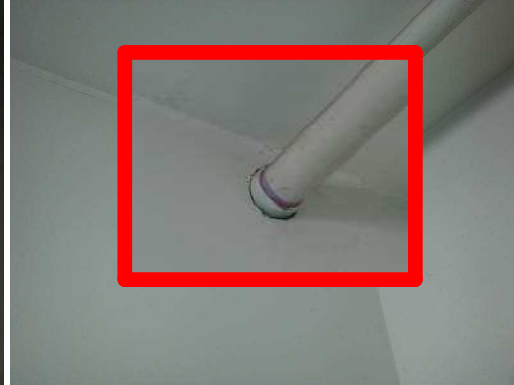
1. Type of Structure: Attached Car Spaces: 2
2. Satisfactory Garage Doors: Metal
3. Satisfactory Door Operation: Mechanized
4. Satisfactory Door Opener: Wayne Dalton
5. Safety Issue Service Doors: Metal, Doors from attached garages into the home should be self closing per current safety standards. Activate spring loaded hinges to correct
6. Safety Issue Walls: Drywall/Plaster, All penetrations in firewall should be sealed. Harmful carbon monoxide gasses can escape into home when firewalls are compromised. PVC pipes should not penetrate firewalls, A qualified contractor is recommended to repair as needed

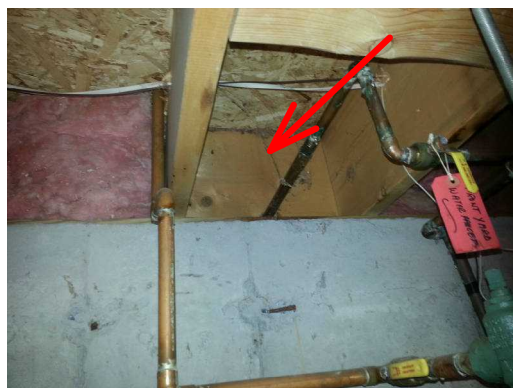
7. Not Present HVAC Source:
8. Satisfactory Insulation: Fiberglass, Add insulation when missing.
Cold air will enter at missing locations

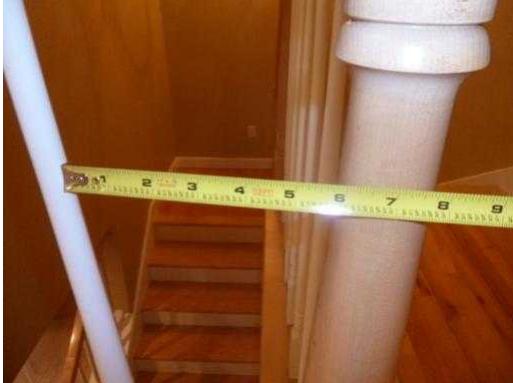
1. Satisfactory Structure Type: Wood frame
2. Satisfactory Foundation: Poured
3. Satisfactory Beams: Solid wood
4. Satisfactory Bearing Walls: Frame
5. Satisfactory Joists/Trusses: 2x10
6. Satisfactory Piers/Posts: Steel posts
7. Satisfactory Floor/Slab: Poured slab
8. Safety Issue Stairs/Handrails: Wood stairs with wood handrails, Spacing between guardrails appears larger than 4" which may allow small children to crawl through the space. Client may wish to reduce spacing as a child safety enhancement

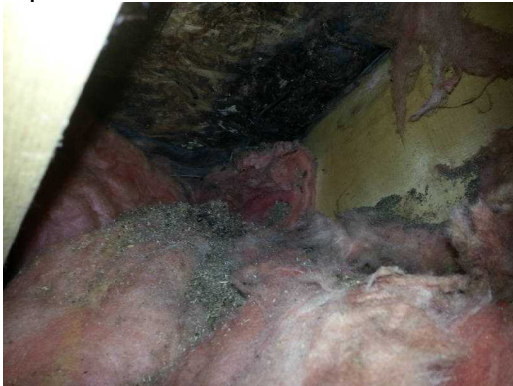
9. Defective Subfloor: OSB, Wood rot present front portion of home near chimney area, Rim joists and sub floor damaged at this area. A qualified contractor is recommended to evaluate and estimate repairs

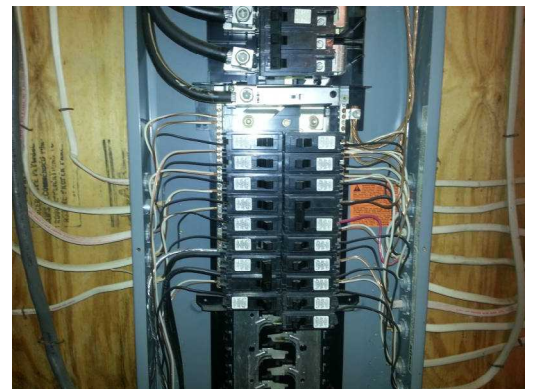
1. Service Size Amps: 200 Volts: 110-240 VAC
2. Satisfactory Service: Aluminum, The electrical system for this home consists of a single-phase, 3-wire, 120/240-volt service

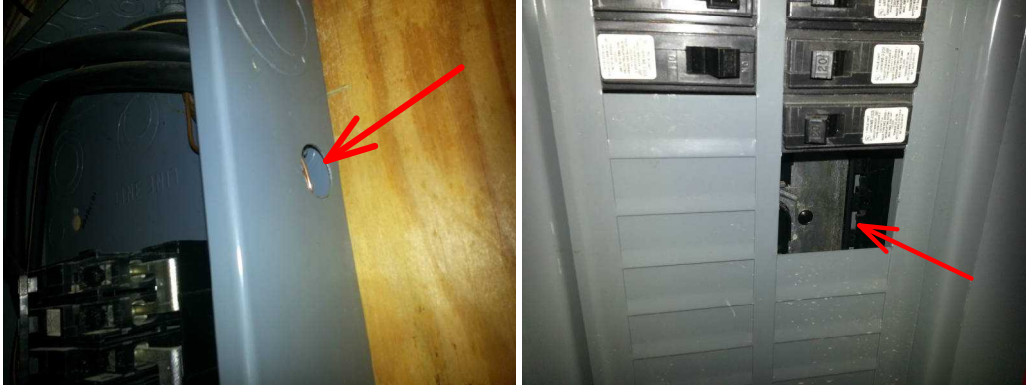
Manufacturer: (continued)

9. Marginal Manufacturer: Square D, Open "knock-out" holes present, insert "blank-out" cap to close openings and to prevent accidental touching of exposed areas. This also will help contain any arc flashes within panel. Metal knockout replacement parts are recommended for improved safety

3. Basement Electric Panel Manufacturer: Square D, Open "knock-out" holes present, insert "blank-out" cap to close openings and to prevent accidental touching of exposed areas. This also will help contain any arc flashes within panel. Metal knockout replacement parts are recommended for improved safety

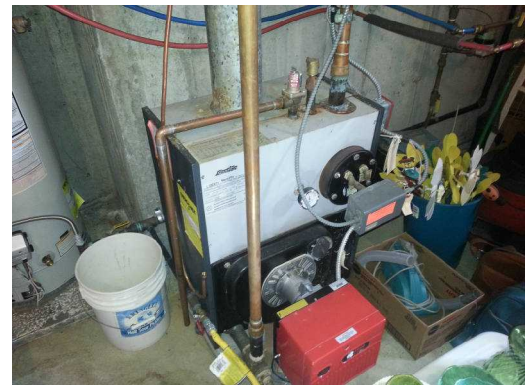
- 1. Satisfactory Heating System Operation: Appears functional, The heating system was operated using normal controls and found to be in satisfactory condition at time of inspection. All heating equipment requires an annual inspection by a qualified heating contractor to ensure safe and efficient operation.

No service records are present so it's recommended to have unit serviced before it's used.

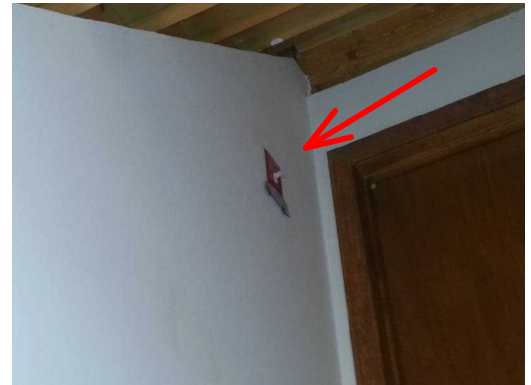
15. Satisfactory Safety Switch Location: Top of stairs, This switch will turn your heating system off in case of an emergency

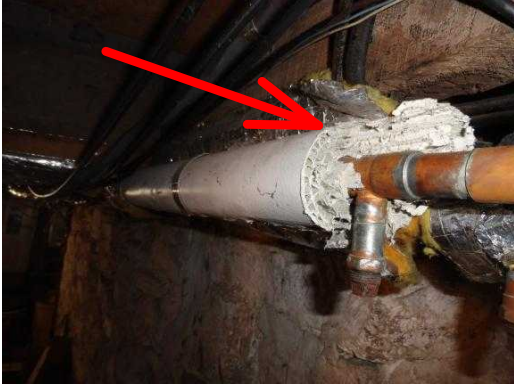
18. Suspected Asbestos: Yes, Suspected friable asbestos present. Appears to be in a friable (deteriorated) condition at various locations. Asbestos can be a health hazard when friable fibers can become airborne. Recommend inspection by a qualified asbestos contractor for best corrective measures

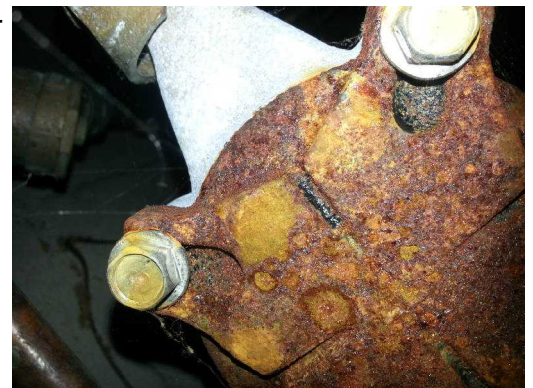
1. Marginal Service Line: Copper, Excessive rust on bottom of water meter. Recommend replacement by town

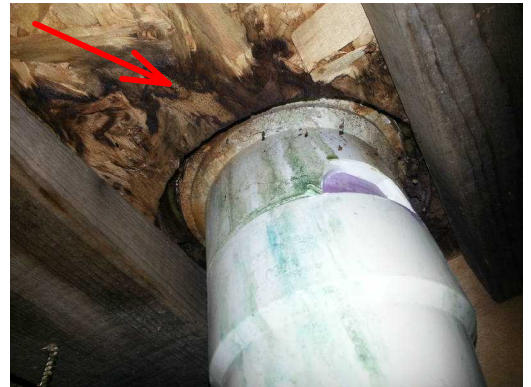
3. Satisfactory Water Lines: Copper
4. Marginal Drain Pipes: PVC, Damaged pipe present under laundry bathroom. Sign of past or present leaks above this area. Repair as needed

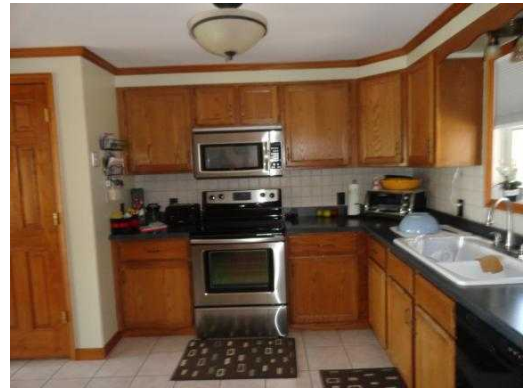
1. Satisfactory Cooking Appliances: General Electric, Stove and burners were operated and found to be in good working condition at time of inspection

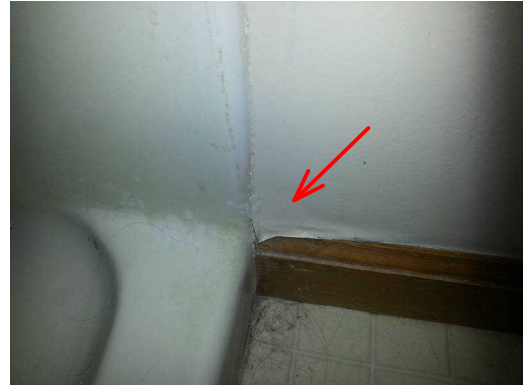
3. Marginal Walls: Drywall/Plaster, Repair as needed. Shower spray has hit wall at this area causing damage

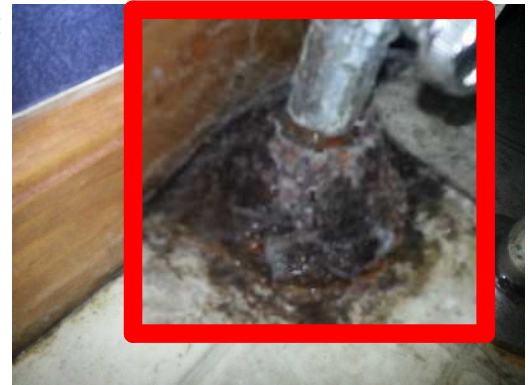
- 30. Satisfactory Ceiling: Sheetrock/Plaster
- 31. Satisfactory Walls: Sheetrock/Plaster
- 32. Satisfactory Floor: Vinyl floor covering
- 33. Satisfactory Doors: Hollow wood
- 34. Satisfactory Windows: Vinyl casement
- 35. Marginal Electrical: Lighting only, Recommend adding receptacle for bathroom. None present. GFCI receptacles are recommended in baths for improved safety
- 36. Satisfactory Sink/Basin: Pedestal
- 37. Defective Faucets/Traps: Chrome fixtures/PVC trap, Active leak at hot water supply, This condition requires repair

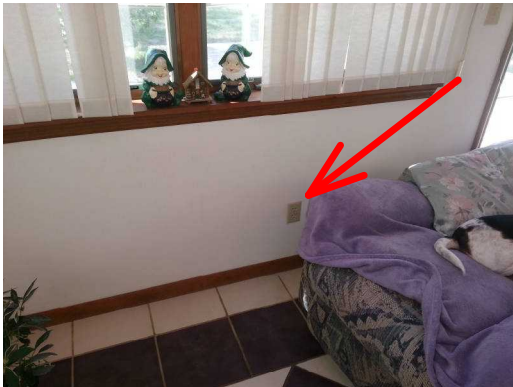
Electrical: (continued)

- 13. Satisfactory Floor: Tile
- 14. Satisfactory Doors: Sliding glass
- 15. Satisfactory Windows: Vinyl casement
- 16. Safety Issue Electrical: 110 VAC, Metal object present in receptacle. This receptacle and one next to it are ungrounded, Replace/repair as needed

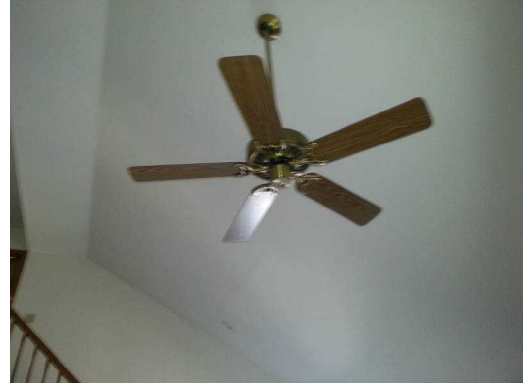
25. Defective Electrical: 110 VAC, Fan inoperable, Recommend correction by qualified electrical contractor

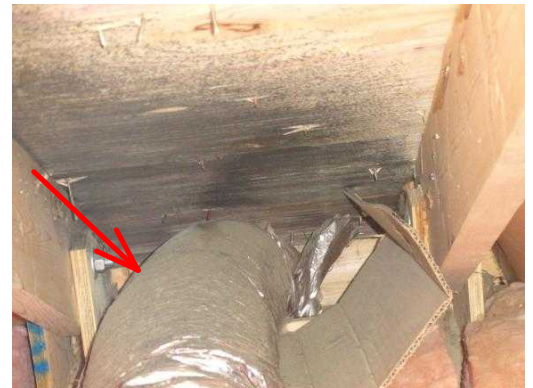
8. Satisfactory Wiring/Lighting: 110 VAC
9. Not Present Moisture Penetration: Nothing observed at time of inspection
10. Defective Bathroom Fan Venting: Electric fan, The Exhaust fan vents into the soffit. All exhaust fans must terminate to the exterior. Possible microbial growth at this location, Recommend correction by qualified contractor

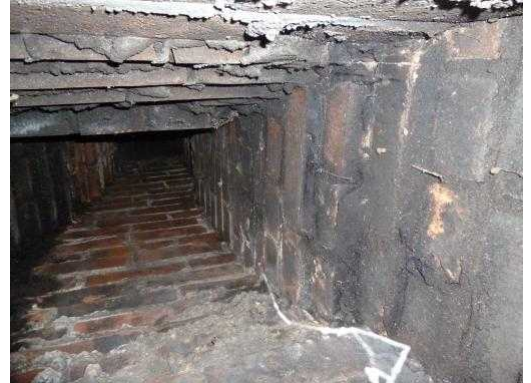
3. Defective Flue: Metal, No flue liner present within chimney,
Recommend repair by qualified contractor

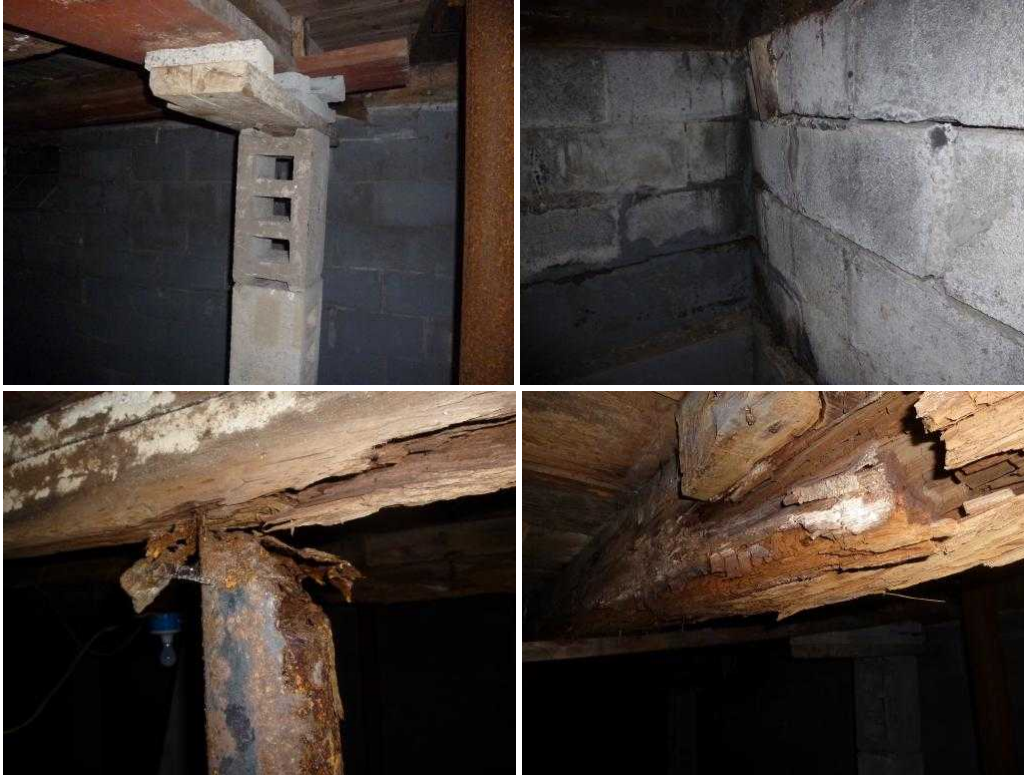
Foundation: (continued)

1. Satisfactory Exterior Surface: Vinyl siding
2. Satisfactory Roof: Asphalt shingle
3. Satisfactory Roof Structure: Wood truss
4. Satisfactory Ceiling: Exposed framing
5. Satisfactory Walls: Exposed Framing
6. Satisfactory Floor: Poured concrete
7. Defective Foundation: Poured slab, Foundation in poor condition throughout. Bowing walls with displaced cracks present in multiple areas. Temporary supports that have been added were not installed in best practice. Wood rot present at several support beams. A structural engineer is recommended to evaluate and estimate repairs

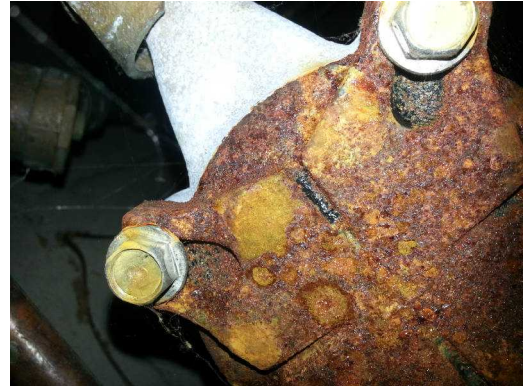
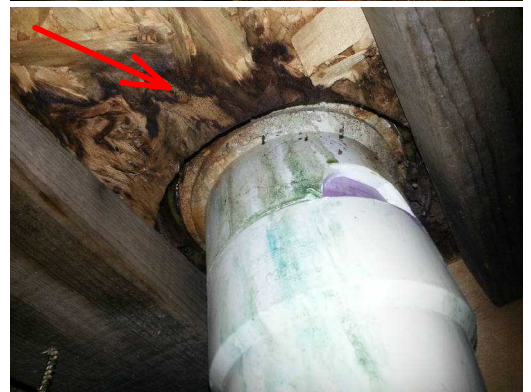
5. Service Line: Copper, Excessive rust on bottom of water meter. Recommend replacement by town
6. Drain Pipes: PVC, Damaged pipe present under laundry bathroom. Sign of past or present leaks above this area. Repair as needed

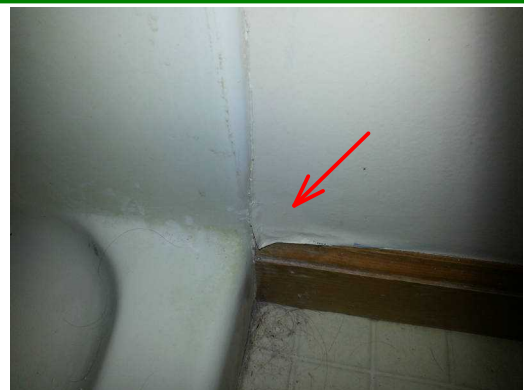
7. Master Bathroom Walls: Drywall/Plaster, Repair as needed. Shower spray has hit wall at this area causing damage
8. 1/2 Bath Bathroom Electrical: Lighting only, Recommend adding receptacle for bathroom. None present. GFCI receptacles are recommended in baths for improved safety
9. 1/2 Bath Bathroom Toilets: Standard Porcelain, Toilet loose at floor. This can require simply tightening the bolts or replacement of the wax seal and or adding a flange extender when needed at thicker floors

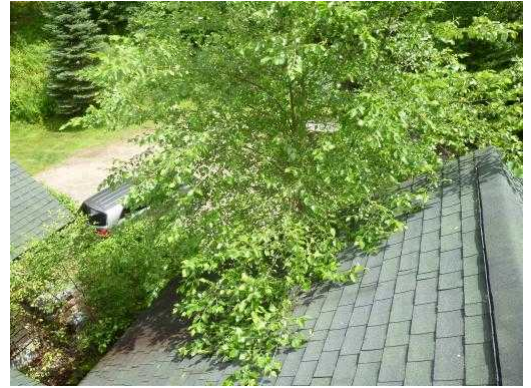
1. Vegetation: Trees with typical lanscape mixture of plants and shrubs, Tree limbs over hang the roof and should be cut back to prevent mechanical and moisture damage to roof and siding areas

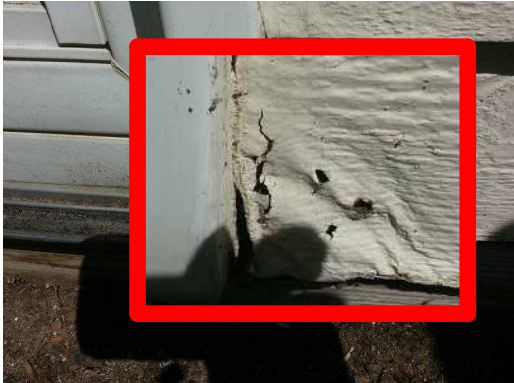
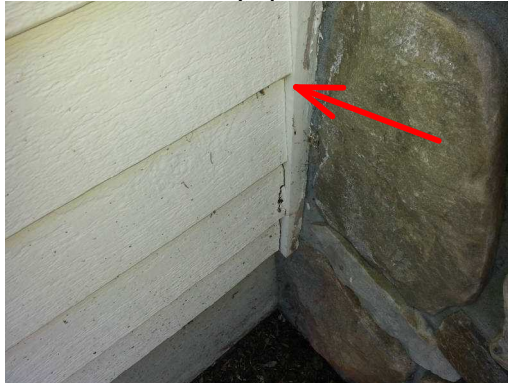
2. All of home Exterior Surface Type: Composite Wood, Small amount of rot present at base of rear patio door and Front of home at chimney transition. Chimney transition area has water penetration into the basement at this location. Recommend further evaluation/correction by qualified contractor

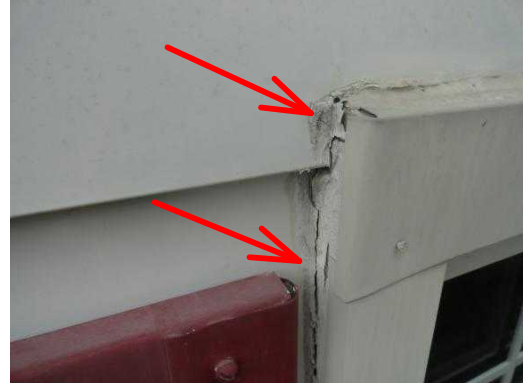
4. Windows: Vinyl casement, Several windows in need of sealing. Water allowed to get behind trim when not properly sealed

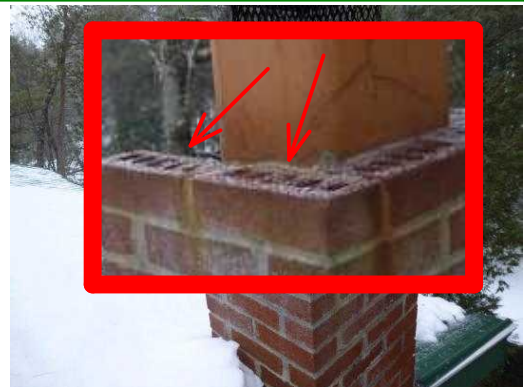
5. Main Chimney Chimney: Brick, Chimney crown not properly installed. Crowns should be designed to deflect water and not collect it. Bricks missing and deteriorating. Consult with qualified mason for correction

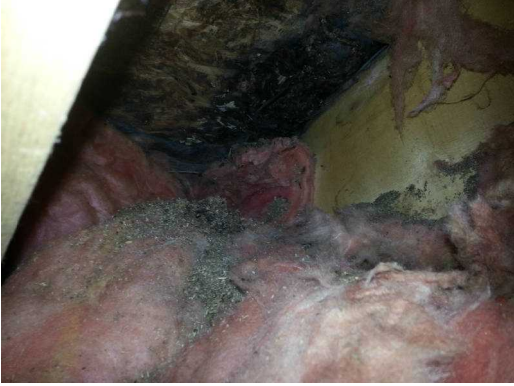
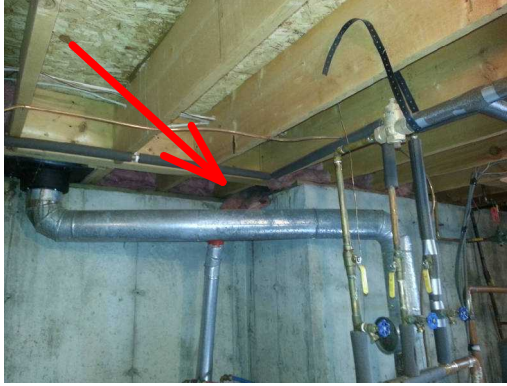
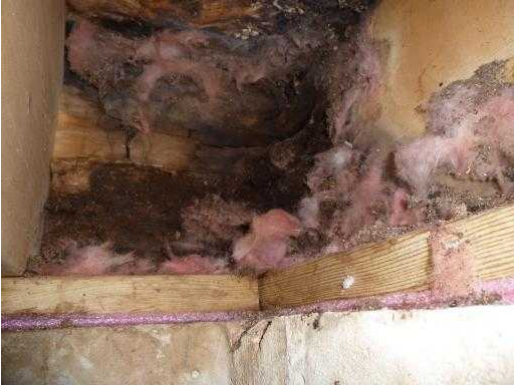
8. Subfloor: OSB, Wood rot present front portion of home near chimney area, Rim joists and sub floor damaged at this area. A qualified contractor is recommended to evaluate and estimate repairs

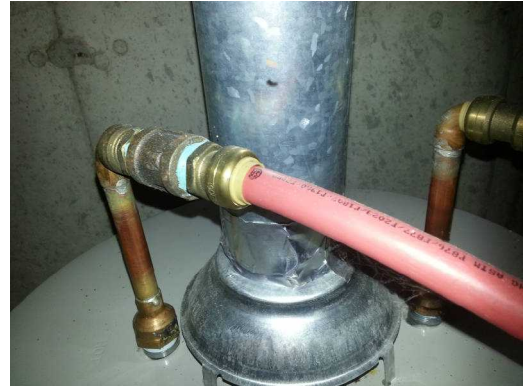
10. Basement Water Heater Water Heater Operation: Functional at time of inspection, PEX tubing should not be installed within the first 18" of piping connected to a gas water heater. PEX should also be kept at least 6" away from flue pipe due to the heat generated. Recommend replacing with copper piping where it enters tank

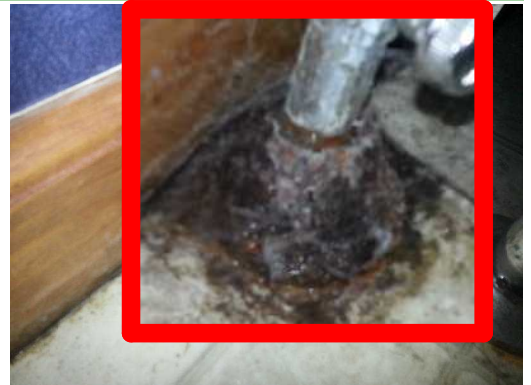
12. 1/2 Bath Bathroom Faucets/Traps: Chrome fixtures/PVC trap, Active leak at hot water supply, This condition requires repair

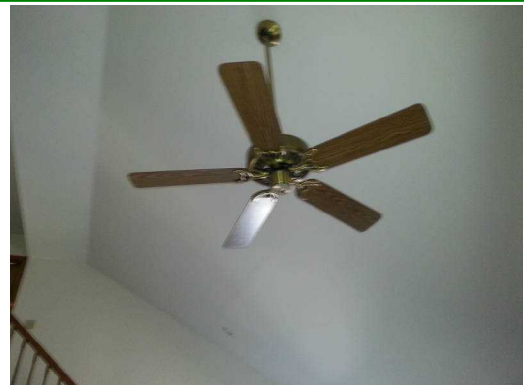
13. Living Room Living Space Electrical: 110 VAC, Fan inoperable, Recommend correction by qualified electrical contractor

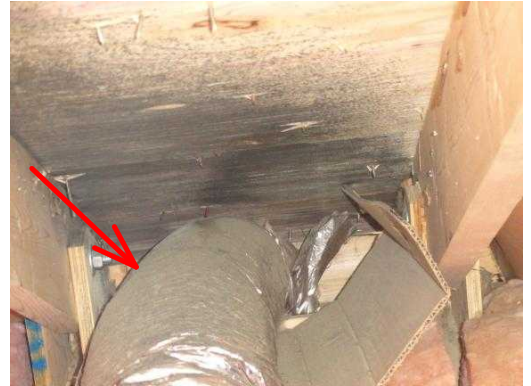
14. Main attic Bathroom Fan Venting: Electric fan, The Exhaust fan vents into the soffit. All exhaust fans must terminate to the exterior. Possible microbial growth at this location, Recommend correction by qualified contractor

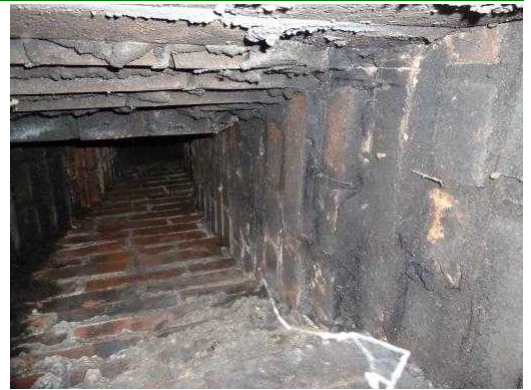
15. Living Room Fireplace Flue: Metal, No flue liner present within chimney, Recommend repair by qualified contractor

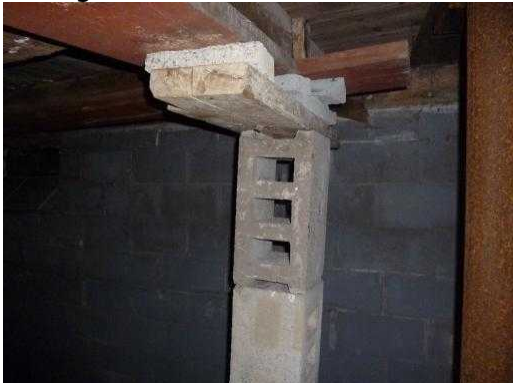
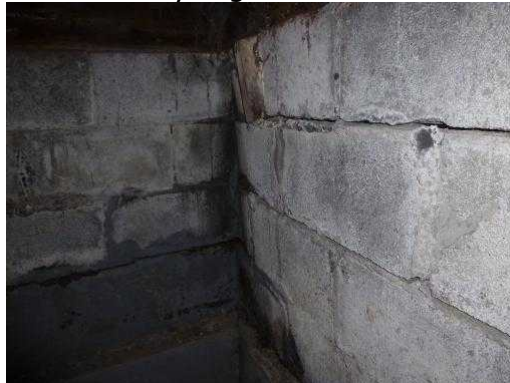
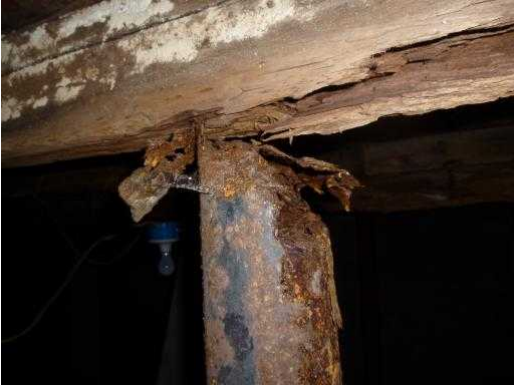
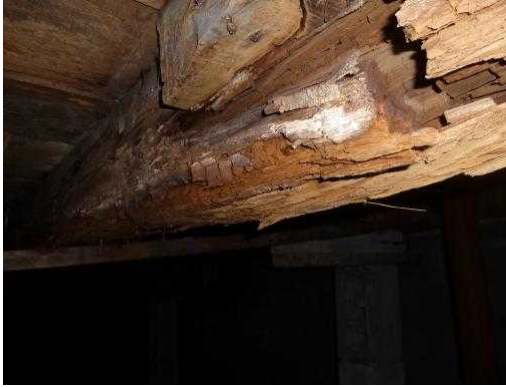
16. Rear of home Outbuilding Foundation: Poured slab, Foundation in poor condition throughout. Bowing walls with displaced cracks present in multiple areas. Temporary supports that have been added were not installed in best practice. Wood rot present at several support beams. A structural engineer is recommended to evaluate and estimate repairs

Building should not be considered safe till evaluated by engineer

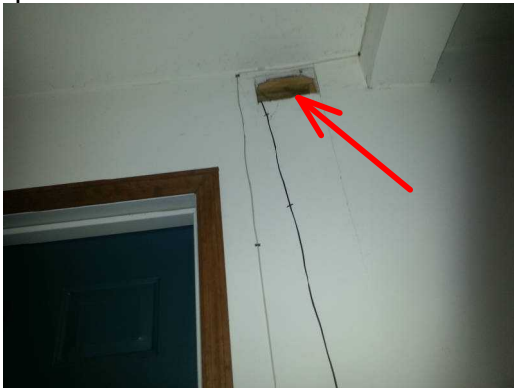
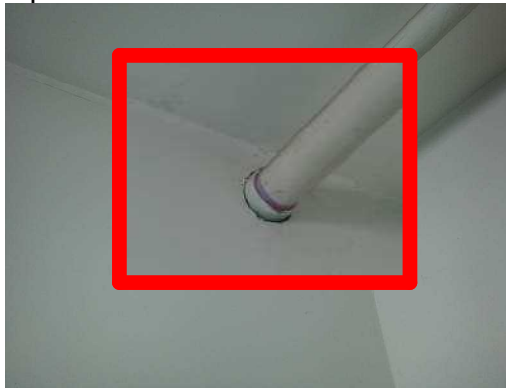
2. Side Garage Service Doors: Metal, Doors from attached garages into the home should be self closing per current safety standards. Activate spring loaded hinges to correct
3. Side Garage Walls: Drywall/Plaster, All penetrations in firewall should be sealed. Harmful carbon monoxide gasses can escape into home when firewalls are compromised. PVC pipes should not penetrate firewalls, A qualified contractor is recommended to repair as needed

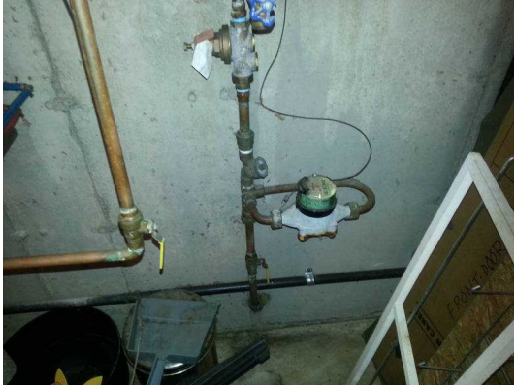
6. Ground: Ground rods, Recommend grounding water lines within 5' of water service entry into home

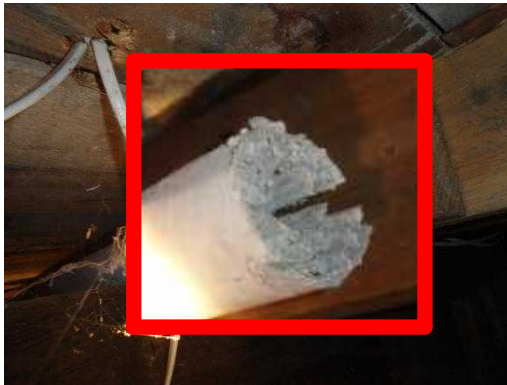
8. Suspected Asbestos: Yes, Suspected friable asbestos present. Appears to be in a friable (deteriorated) condition at various locations. Asbestos can be a health hazard when friable fibers can become airborne. Recommend inspection by a qualified asbestos contractor for best corrective measures

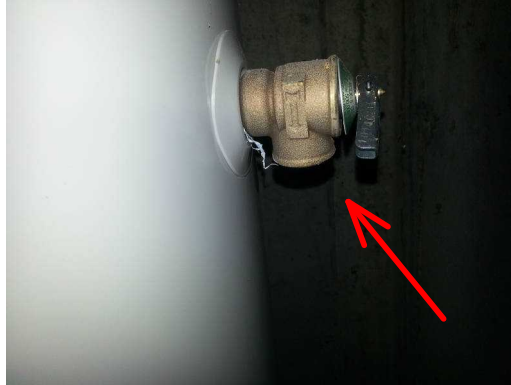
9. Gas Service Lines: Black iron, CSST, Recommend bonding all gas lines within the home
10. Basement Water Heater TPRV and Drain Tube: Missing, Missing discharge drain tube. Add drain tube and direct to within 6" of the floor to prevent scolding in case of discharge

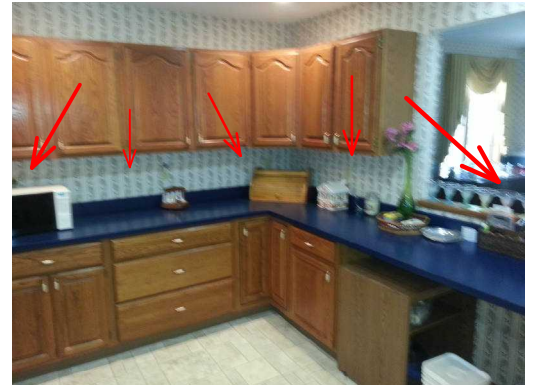
12. 1st Floor Kitchen Electrical: 110 VAC GFCI, All countertop receptacles should be GFCI protected for added safety

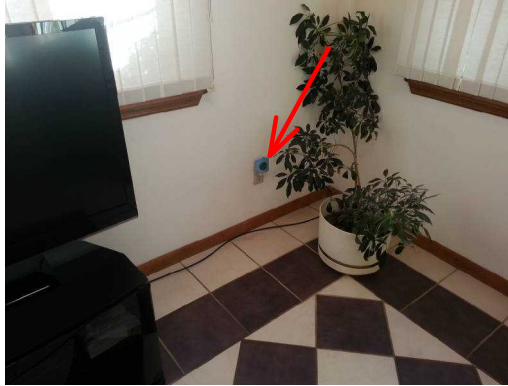
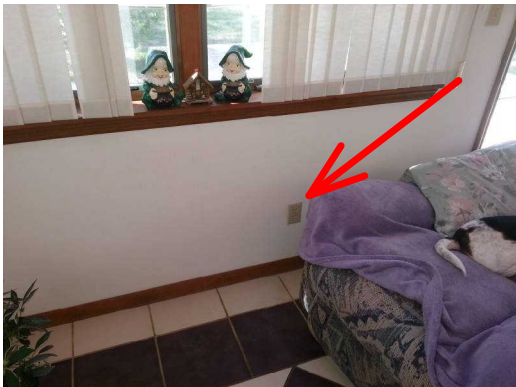
17. Sun room Living Space Electrical: 110 VAC, Metal object present in receptacle. This receptacle and one next to it are ungrounded, Replace/repair as needed

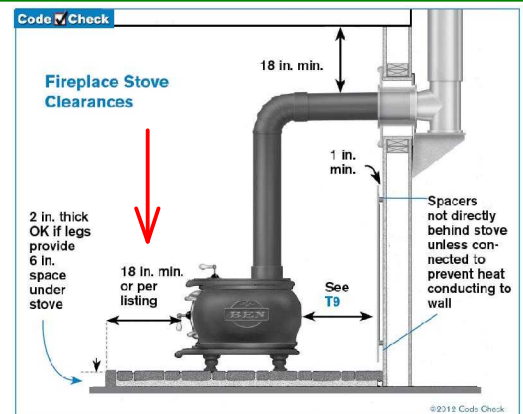
19. Living Room Fireplace Hearth: Cultured stone, Front of stove should have at least an 18" clearance to combustible flooring. As currently installed clearance is less than 6 inches
